Fountain View on the Plaza Parking Garages' Structural Strengthening and Concrete Repair and Protection

Fountain View on the Plaza Parking Garage

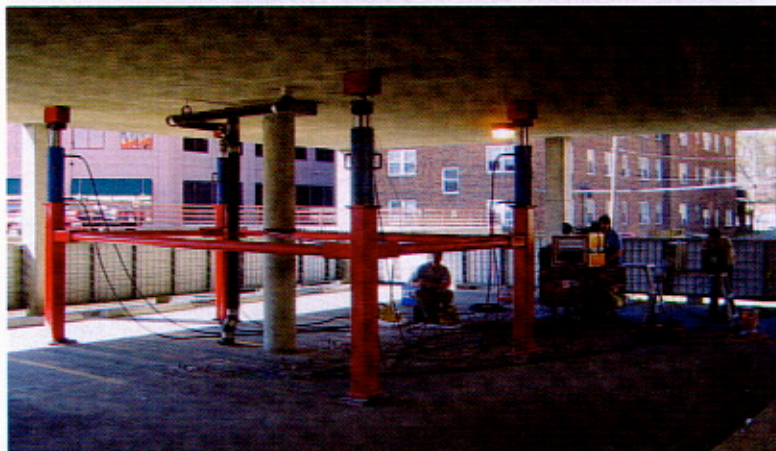
Fig. 1: Load testing of slab using hydraulic jacks and steel frame to apply the loads. Note the computers acquiring data

The load test objective was to demonstrate the feasibility of Option 1 to effectively increase the structural capacity of the slabs. A garage area showing typical overstresses (25% for flexural capacity and 30% for punching shear capacity) was selected to test both options. The load test was designed to simulate the stress condition caused by the uniformly distributed self weight and vehicular traffic load. The test loads were generated by four hydraulic jacks controlled by manual pumps, which applied the load to the slab through a steel frame (Fig. 1) and reacted against the floors above. Several sensors were connected to a computer and installed under the slab to monitor displacements and deformations of the slab during the load tests (Fig. 2).

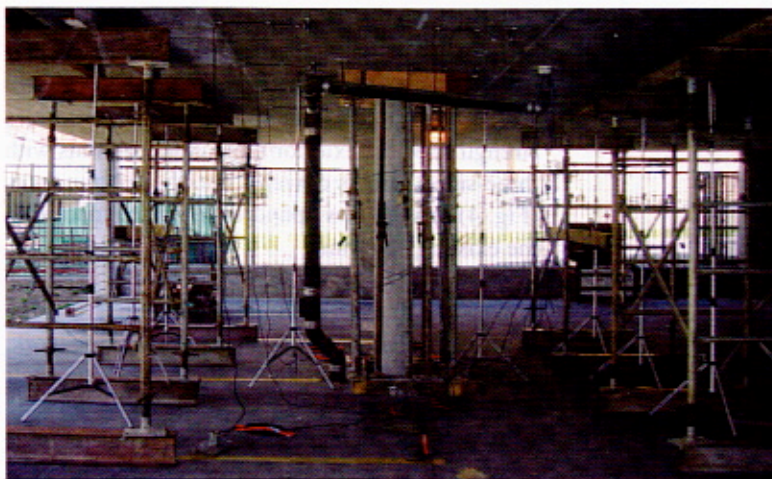
Fig. 2: Underside of test slab showing sensors during load test of Option 2. Shoring was used as a safety measure (it was not in contact with the slab bottom)

Load testing of Option 2 was conducted first. The test simulated the presence of a shear collar using shoring posts. The load test of Option 1 occurred after installing CFRP laminates in the mock-up area. The test results demonstrated the effectiveness of Option 1. Therefore, this option was selected to strengthen areas with typical overstresses. For areas with larger overstresses,

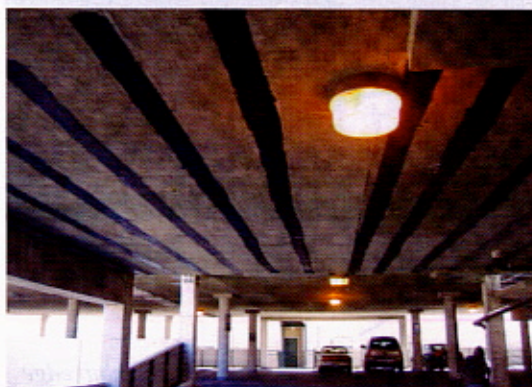
Fig. 3: Slab underside strengthened with CFRP laminates

Flexural strengthening of positive moment regions (slab underside) was also undertaken where the slab strength was inadequate due to the incorrect placement of the tendons. This strengthening was accomplished with a CFRP laminate system placed on the bottom of the slab (Fig. 3).

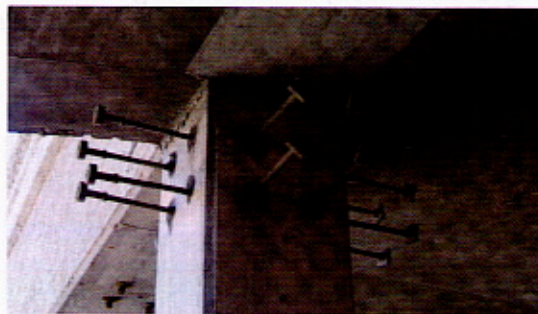
Fig. 4: Headed bars used in the construction of external shear collars

There was also a need for punching shear strengthening of slab/column intersections. At interior columns, this strengthening was accomplished by installing shear collars. Shear collars strengthened the exterior/ramp edge columns with three-sided corbels doweled into the column faces (Fig. 4) or with new spandrel beams connected to the existing columns.

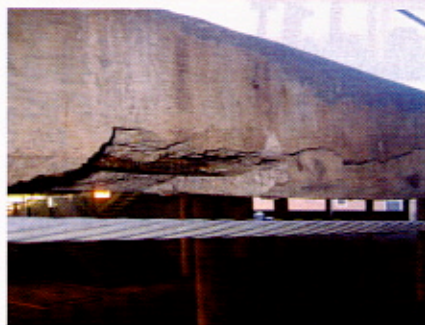
Fig. 5: Cracking on slab edge shown before and after repair

2. Repairing hollow-sounding areas of concrete and previous repairs on the underside of the slab below the banded tendons where the concrete/repairs were cracked;
3. Repairing areas of slab with horizontal cracks on the exposed slab edge (Fig. 5);
4. Repairing stressing pockets where the grout-fill had gaps and/or showed signs of leakage, and filling grout pockets that were ungrouted;
5. Injecting epoxy into column cracks resulting from the restraint of slab post-tensioning and other volume changes;
6. Repairing spalled column tops;
7. Routing and filling cracks in the topside of the slab with methacrylate resin;
8. Applying vehicular traffic-bearing waterproofing on the elevated slabs. The waterproofing was extended down the vertical faces of the exposed slab edges to provide additional protection to the ends of the tendons; and
9. Applying penetrating sealer to all the slabs-on-ground.
