DESTRUCTIVE TESTING

OF AGING WOOD POLE H-FRAME STRUCTURES

115 KV TESTS Structures in Service since 1936

138 KV TESTS Structures in Service since 1939

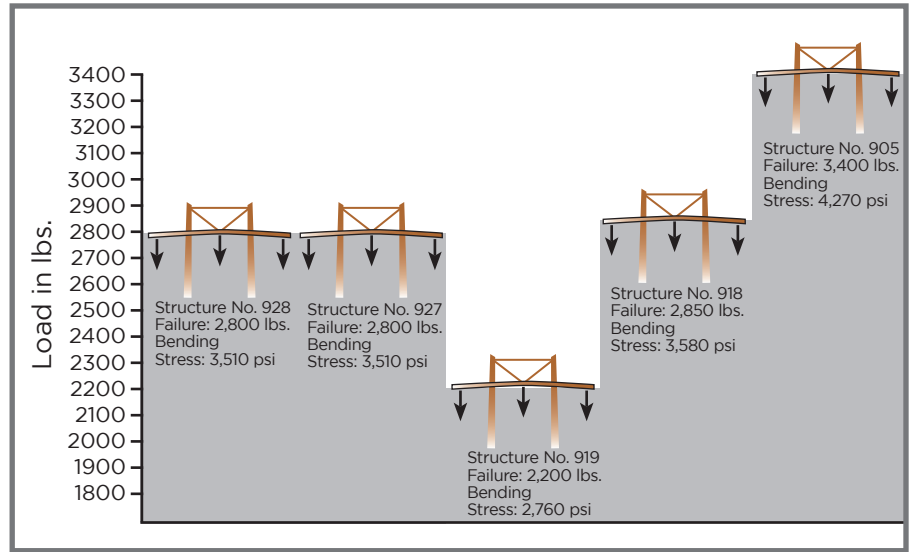
Crossarm Tests

Five of the structures crossarm assemblies were first tested vertically to NESC "Heavy" loading requirements. Each arm was reinforced with stainless steel bands after initial failure so they would not have to be replaced for the structure tests.

The sample size was small, but the testing showed that the crossarms still have sufficient strength to support the NESC Heavy loads with an OCF of 2.2. The average failure stress after 60 years of service was about 50% lower than new Douglas fir arms.

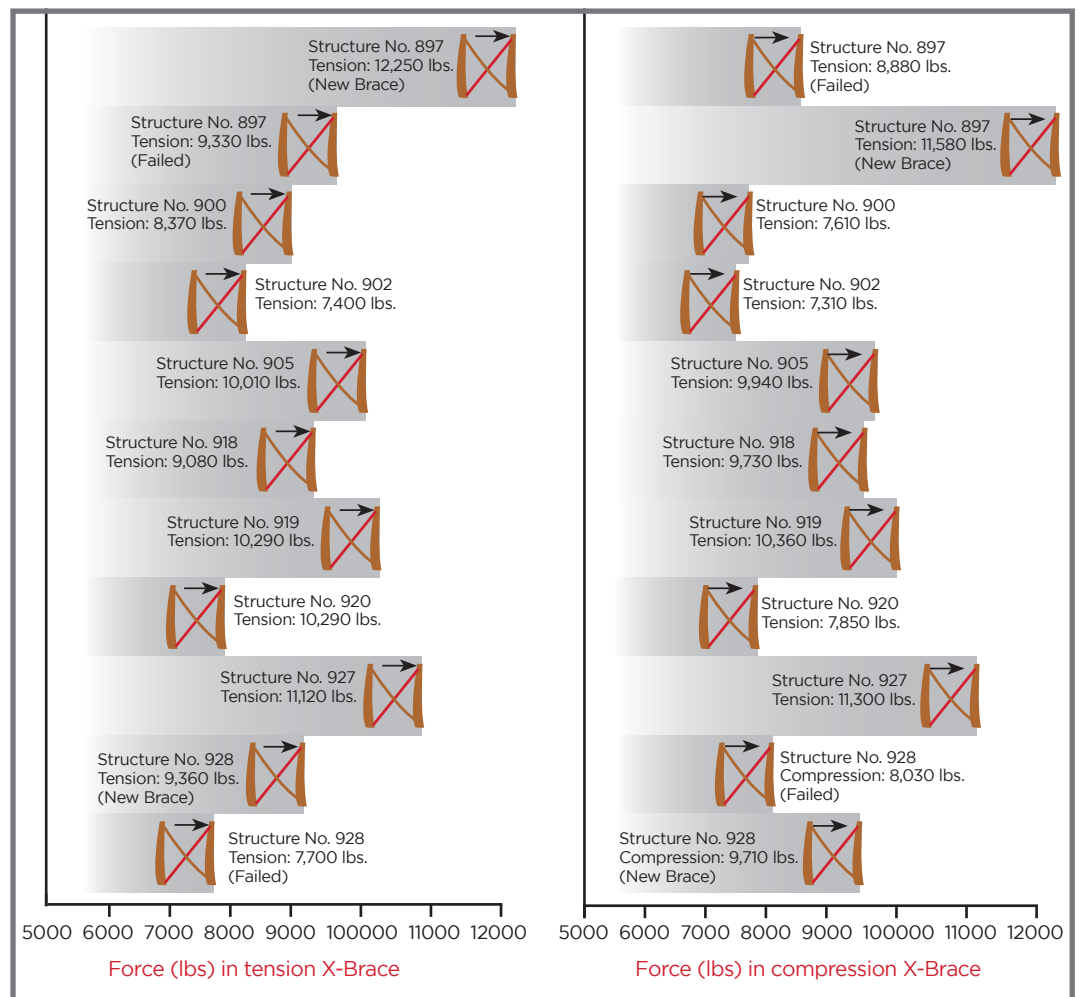
X-Brace Results

The axial tension and compression forces in the X-braces at the time of structure failure were also calculated and are tabulated as shown. In two of these cases the X-brace failed before the poles, and they were replaced with new X-braces so the structures could be tested further.

The original X-braces had a 3-3/8 x 4-3/8 cross section, which is not a recommended size for this pole spacing. Weathering reduced this section by about 1/16" on all faces, resulting into an approximate 12-13% reduction in buckling capacity. The X-braces performed adequately in spite of the weathering and loosening of some hardware.

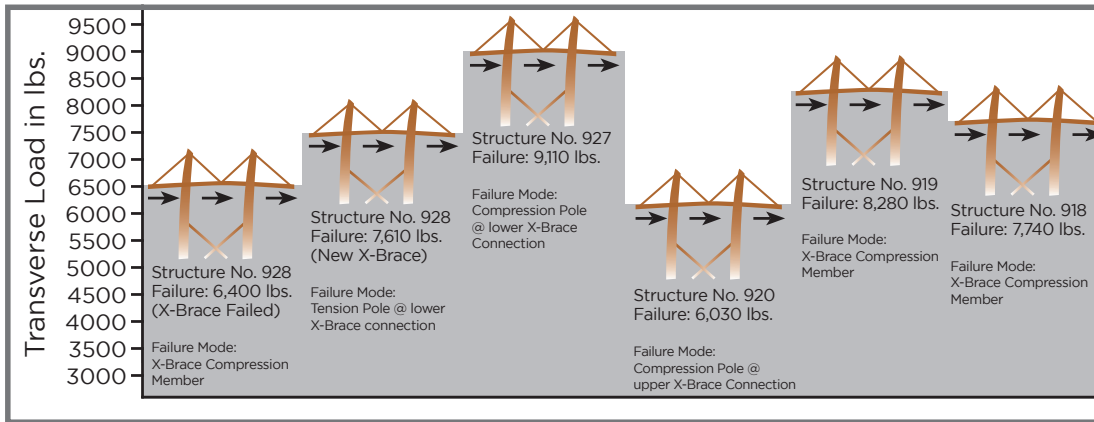
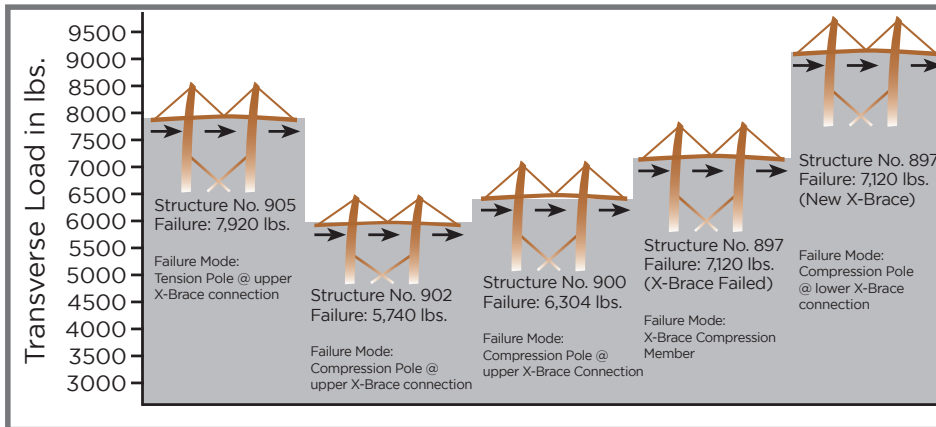
Transverse Loads & Failure Mode

The results of the combined transverse and vertical load tests are tabulated below. Based on an original designated fiber stress of 6,000 psi for new western red cedar poles the structures should have failed near 11,680 pounds. The “at replacement” failure load should have been about 7,820 pounds. These loads were calculated based on ANSI minimum pole dimensions.

The structures performed well considering their age. The average failure load was only 5% below NESC “at replacement” requirements.

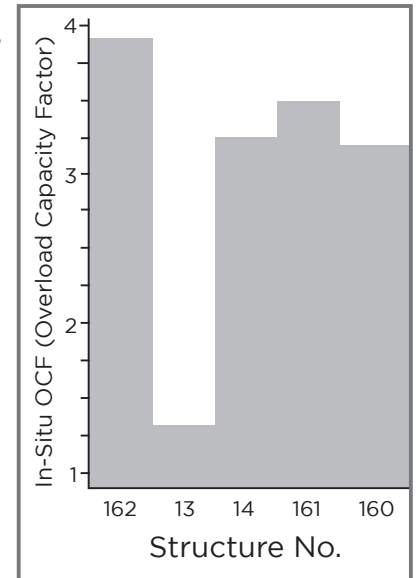
In-Situ OCF

The tests for Wisconsin Power and Light show that simple maintenance such as tightening bolts or replacing missing hardware can increase the life of the structures significantly. The average failure load of these structures, even considering the missing center clamp, was well over the “at replacement” requirements.

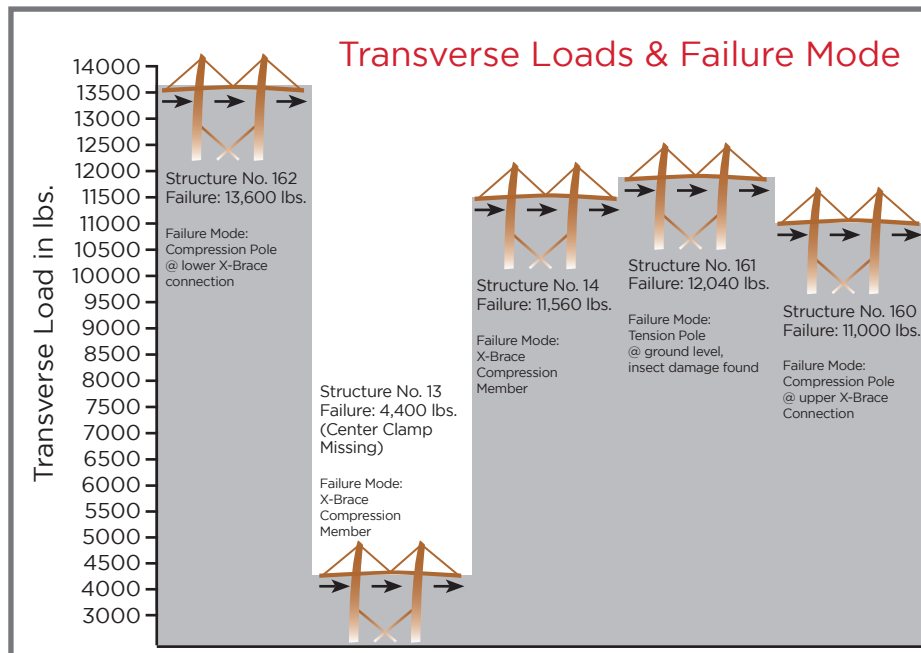
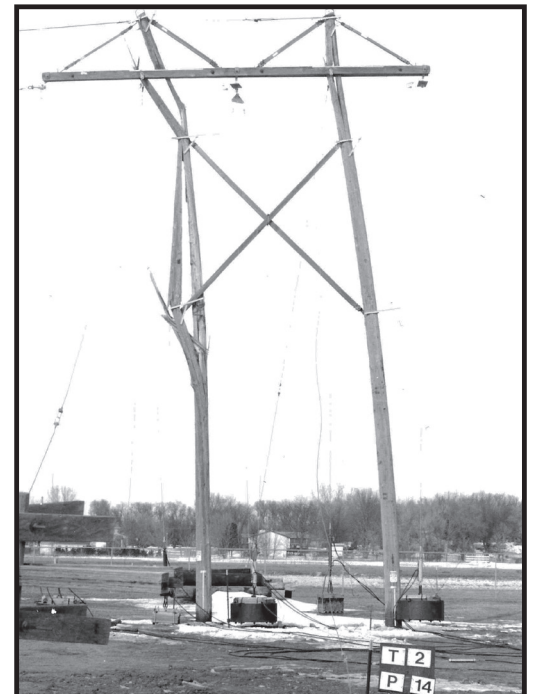
The results of the combined transverse and vertical load tests are tabulated below. Based on an original designated fiber stress of 6,000 psi for new western red cedar poles, the structures should have failed near 13,900 pounds. The “at replacement” failure load should have been about 9,270 pounds. These loads were calculated based on ANSI minimum pole dimensions.
