# DIAPHRAGM WALL AND BARRETTE CONSTRUCTION FOR THIAM RUAM MIT STATION BOX, MRT CHALOEM RATCHAMONGKHON LINE, BANGKOK

Construction experience of cast-in-situ diaphragm walls and foundation barrettes for the Thiam Ruam Mit Station, Chaloe Ratchamongkhon line of Metropolitan Rapid Transit Authority (MRTA) is briefly reported in this paper. The construction activities in the midst of heavily congested traffic and in the vicinity of underground utilities to meet the specified quality and safety controls are also presented.

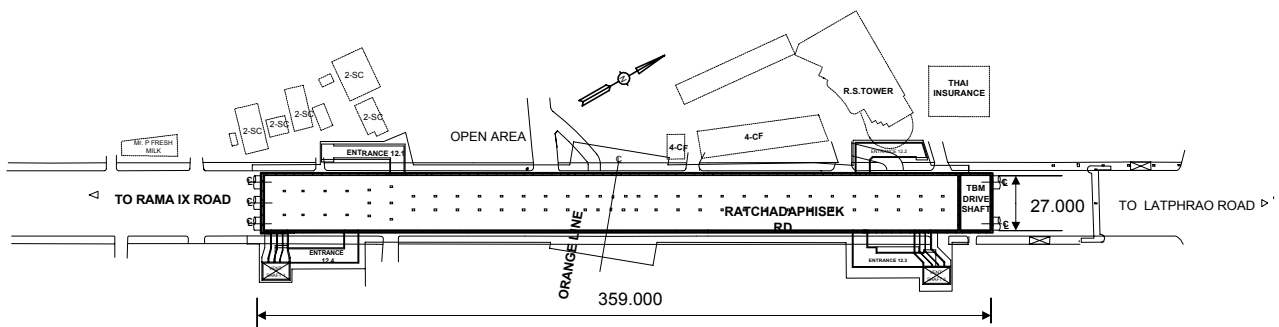
Figure 3. Layout of station box

The station is one of the biggest stations and located on the Ratchadaphisek Road. The station box is enclosed by principally 1.0m thick side walls and 1.20m thick end walls 32.0-42.0m deep. A Tunnel Boring Machine (TBM) launching shaft was included in the north side of the station. To facilitate top-down construction, 63 Barrettes (1.2mx3.0m) embedded 44.5-55.0m deep in conjunction with pre-placed stanchions at the top were used.
