# DESTRUCTIVE TESTING

## OF AGING WOOD POLE H-FRAME STRUCTURES

## 115 KV TESTS Structures in Service since 1936

## 138 KV TESTS Structures in Service since 1939

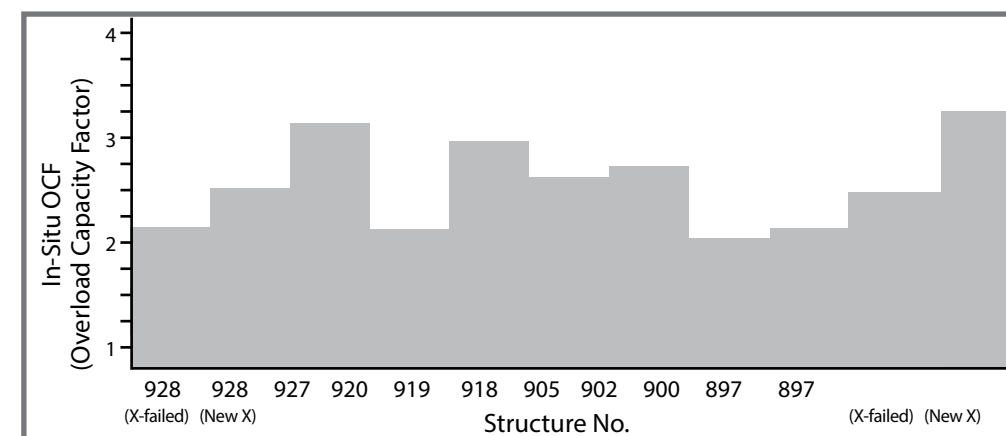
### In-Situ OCF

The structures performed well considering their age. The average failure load was only 5% below NESC "at replacement" requirements.

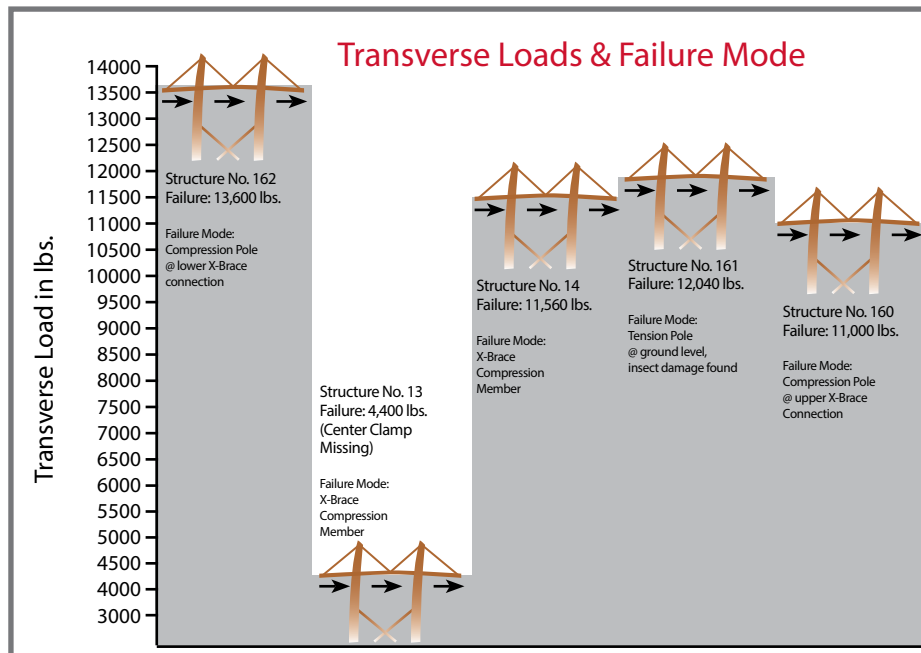
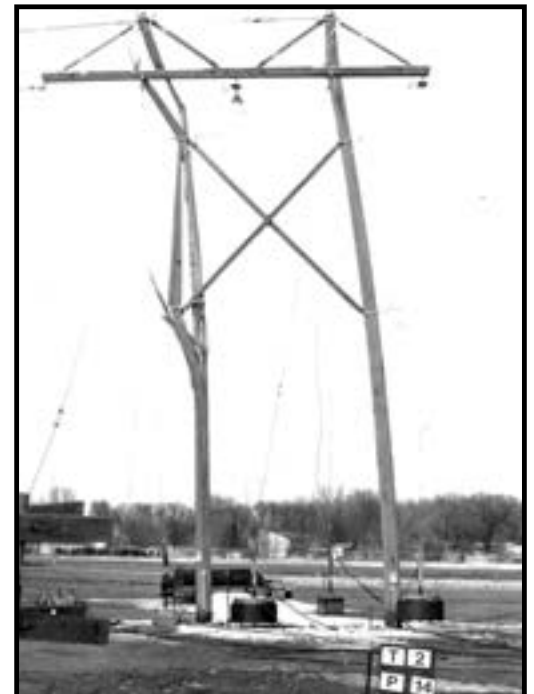
The results of the combined transverse and vertical load tests are tabulated below. Based on an original designated fiber stress of 6,000 psi for new western red cedar poles, the structures should have failed near 13,900 pounds. The "at replacement" failure load should have been about 9,270 pounds. These loads were calculated based on ANSI minimum pole dimensions.
