DESTRUCTIVE TESTING

OF AGING WOOD POLE H-FRAME STRUCTURES

115 KV TESTS Structures in Service since 1936

138 KV TESTS Structures in Service since 1939

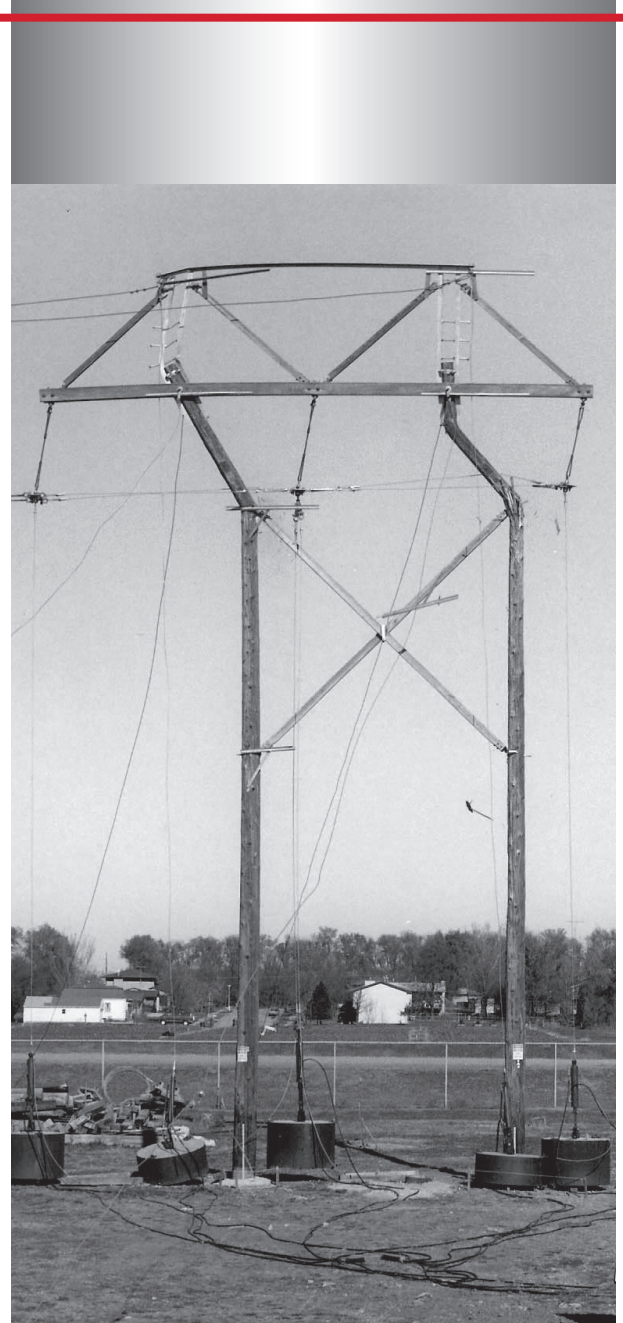
Five of the structures crossarm assemblies were first tested vertically to NESC "Heavy" loading requirements. Each arm was reinforced with stainless steel bands after initial failure so they would not have to be replaced for the structure tests.

The sample size was small, but the testing showed that the crossarms still have sufficient strength to support the NESC Heavy loads with an OCF of 2.2. The average failure stress after 60 years of service was about 50% lower than new Douglas fir arms.
